Work in focus - Brgy. 7 – Lipa City

Completion of 7 new electricity masts is deficient.

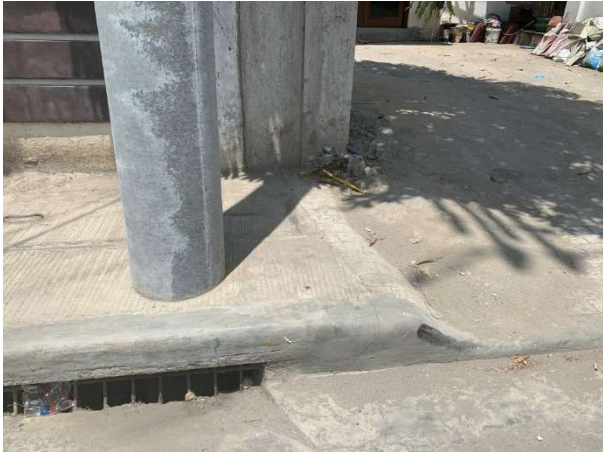
Photo 1

Mast 1

Placed outside pipes: No

Re-establishment: Yes

Clean-up: No

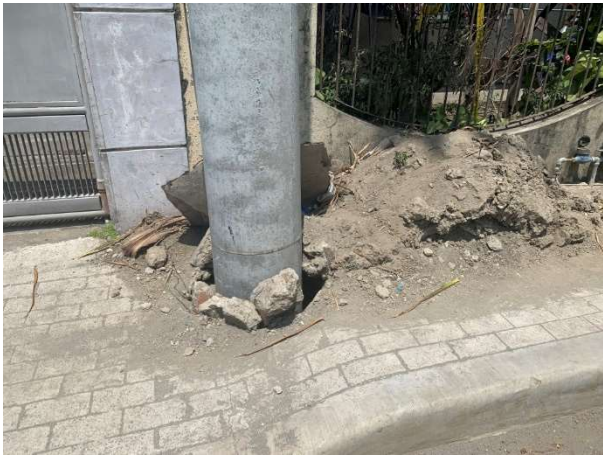
Photo 2

Mast 2

Placed outside pipes: No

Re-establishment: No

Clean-up: No

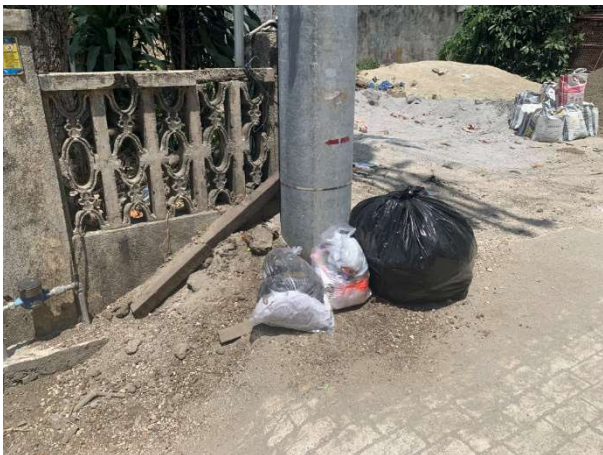
Photo 3

Mast 3

Placed outside pipes: Yes

Re-establishment: Yes

Clean-up: No

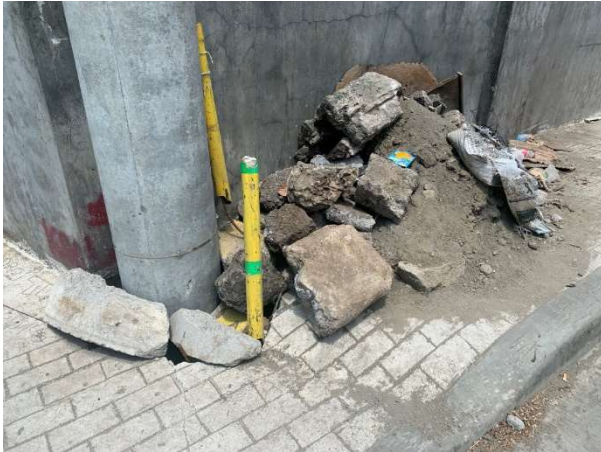
Photo 4

Mast 4

Placed outside pipes: No

Re-establishment: No

Clean-up: No

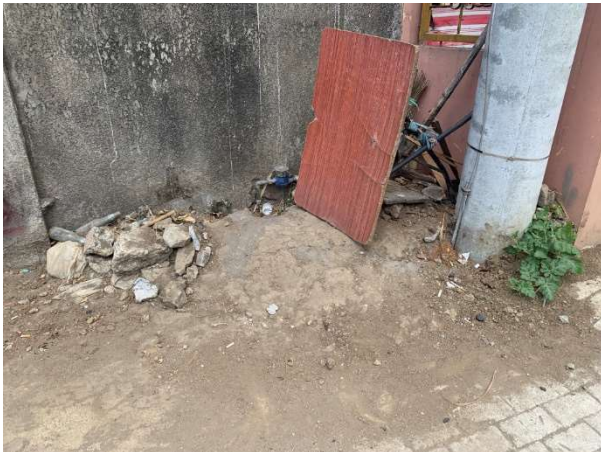
Photo 5

Mast 5

Placed outside pipes: Yes

Re-establishment: Yes

Clean-up: No

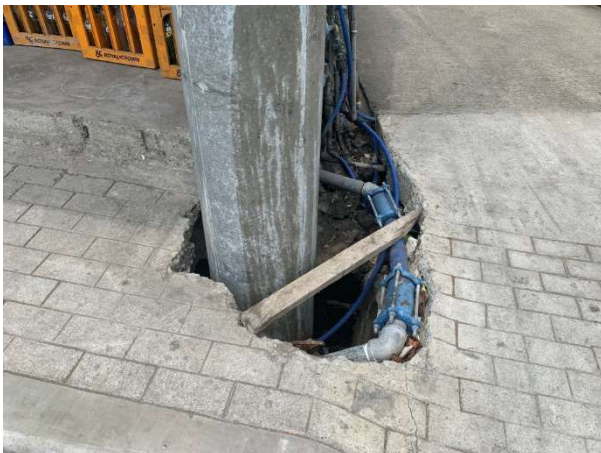
Photo 6a

Mast 6

Placed outside pipes: No

Re-establishment: No

Clean-up: Yes

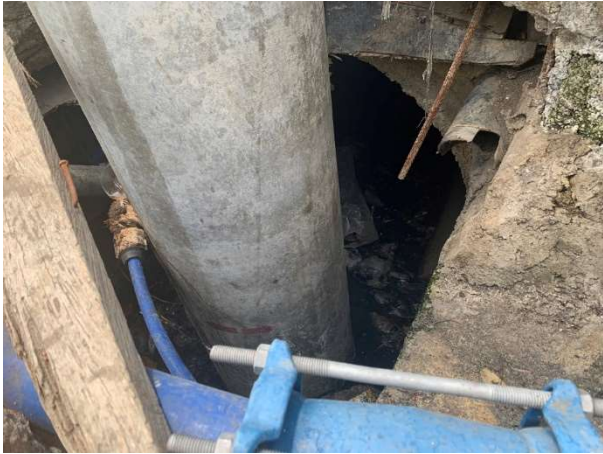
Photo 6b

Mast 6

Placed in the middle of the pipe!

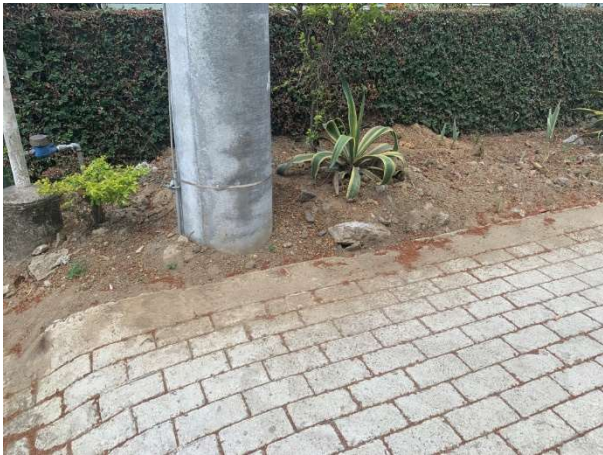
Photo 7

Mast 7

Placed outside pipes: Yes

Re-establishment: Yes

Clean-up: No
